Report No: CS000744

Client	Apache Canada Ltd.	Inspection Date	Mar 20, 2012		
Prov. Reg. #	AB 0497263	Inspection Type	VE / UT		
Equipment Type	Horizontal Inlet Separator	Location	Zama		
Tag/Equip.	V-100	LSD	AB 16-15-118-07W6		
Status	In Service	Downhole LSD			
Manufacturer	Orban Industries Ltd	Area	Shekilie		
Serial Number	03.070HS	Year Built	2003		
CRN #	R2234.2	Service	Sour		
Comp/Unit Id	Horizontal Separator Building	Manway	None		
Nat.Board #		Coating			
Interim Insp'n		Interim Type			
Next Inspection	2015	Next Insp Type	VE / UT		
Length		Height			
Volume		Client Reference			
Owner	Apache Canada Ltd.	RT	1	HT	YES
Foreman	Kelly Franke	RAE Job No.	2673		
ABSA	Plant: H Vessel: K Process: W Special: B	ASME	Sec. VIII div. 1		
History Log

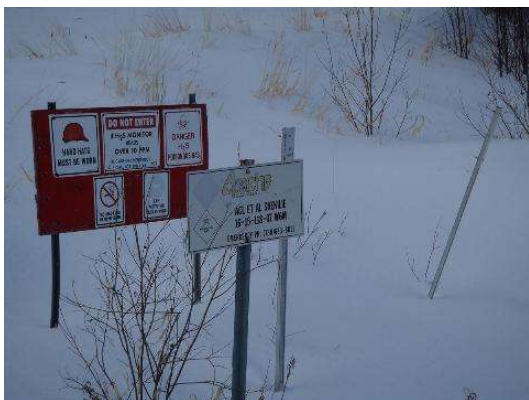
Figure: 1

Vessel Location

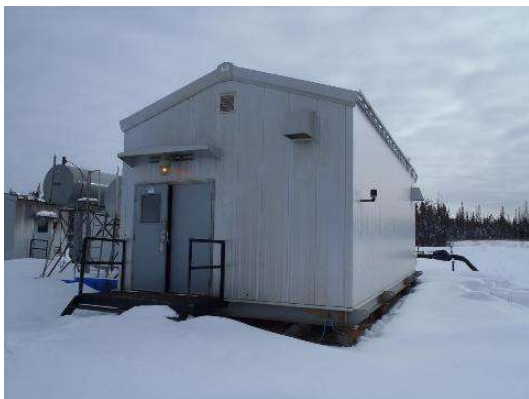
Figure: 2

The building is generally in good condition and well supported. The floor was clean and was checker plate steel. The building is well lit and the door functions well. There was generally good access to the equipment in the building.

Building Overview

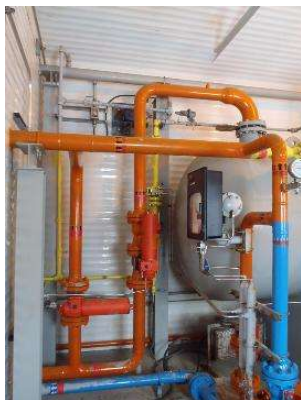
Figure: 3

The associated piping is flanged and threaded. The piping appears in generally good condition. There is no damage, distortion or stress evident on piping. The piping is adequately supported. The piping is fully painted and in good condition with minor paint chipping. The pipe flanges and bolting appear in good condition. The flange connections are fully bolted. The threaded piping is in the same condition as the flanged.

Piping1

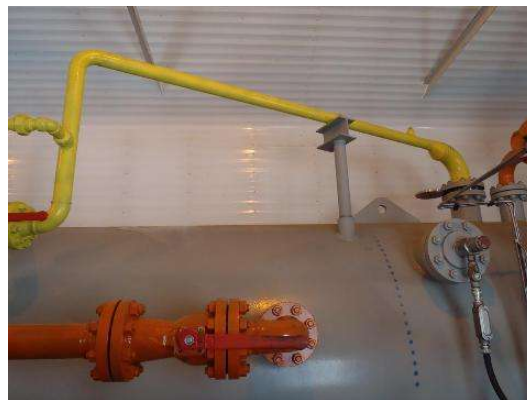
Figure: 4

Piping2

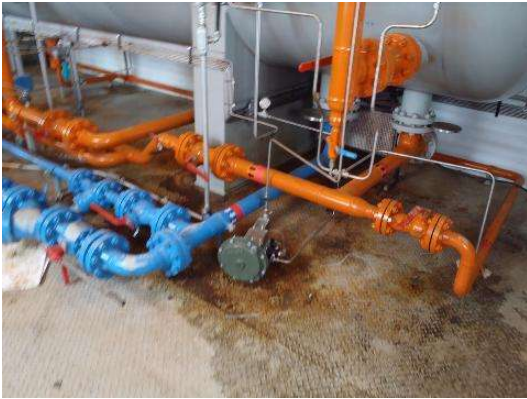
Figure: 5

Piping3

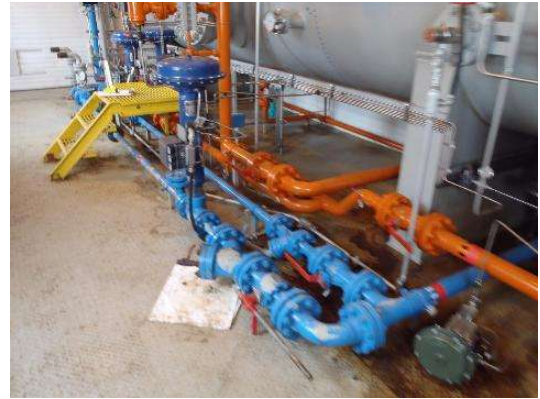
Figure: 6

Piping4

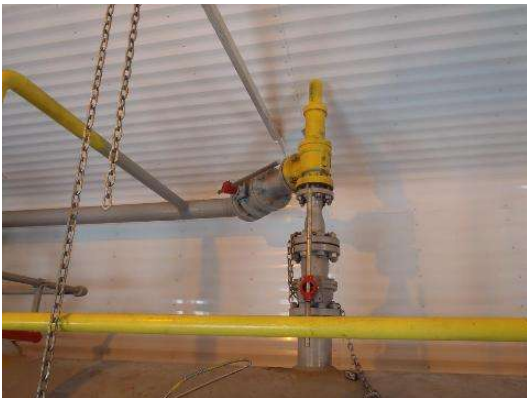
Figure: 7

NCR - Block valves on PSV piping need to be carsealed in the open position.

The PSV is located on the vessel inside the building. The PSV nameplate is secure to PSV. The PSV service tag is attached. The seal wire is intact. The PSV is set to the correct set pressure. The vent size is adequate. The PSV is vented safely. The PSV service reports have not been reviewed, but there are no concerns that would require the service interval to be reduced.

PSV Overview

- Block valve on PSV piping is not carsealed in the open position. Lock valve in the open position.
- Vessel is fit for continued service.

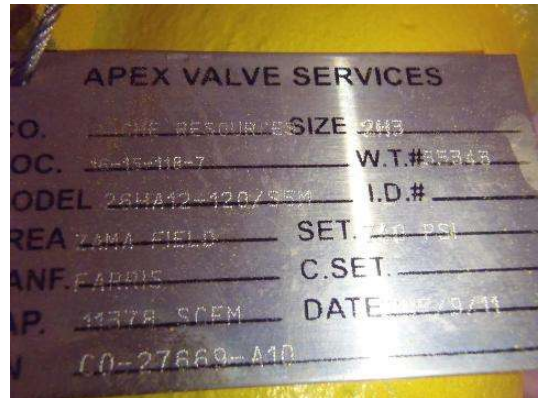
Figure: 8

PSV Service Tag

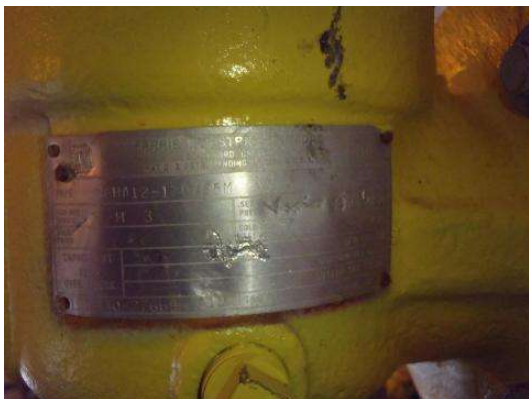
Figure: 9

PSV Nameplate

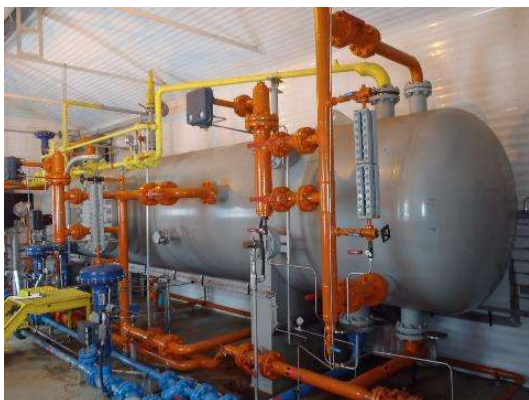
Figure: 10

The vessel nameplate is legible and securely attached to the vessel. The vessel was identified via the A-number and the serial number stamped on nameplate of the vessel. The heads, shell and nozzles and bolting appear in good condition. There is no damage or distortion evident on the vessel surface. There is no stress on piping or nozzle connections. The vessel is adequately supported. The vessel is fully painted inside the building; the paint is in good condition with minor paint chipping.

Vessel Overview

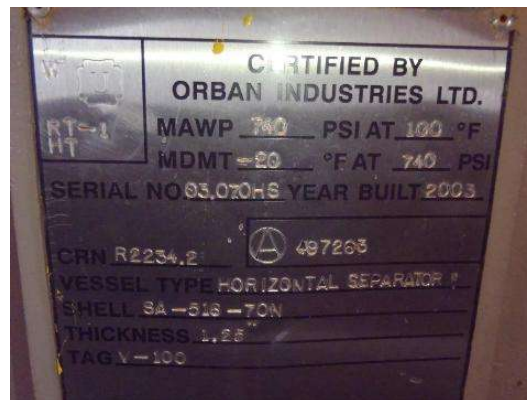
Figure: 11

Vessel Nameplate2

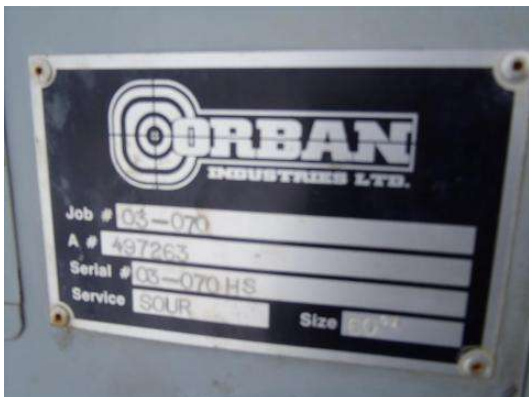
Figure: 12

Vessel Nameplate1

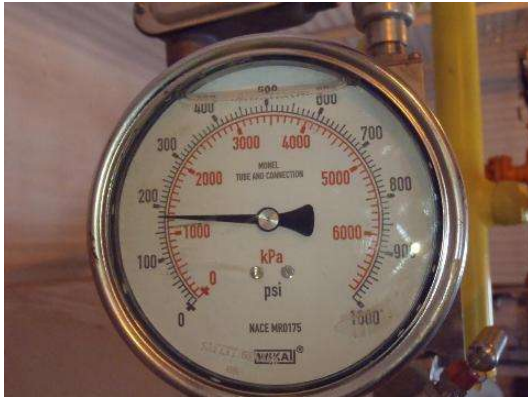
Figure: 13

Equipment was in operation at time of inspection. There are no leaks evident on piping connections and/or controls. No vibration induced damage is evident. The gauge(s) and associate equipment all appear in good condition and operational.

Pressure Gauge

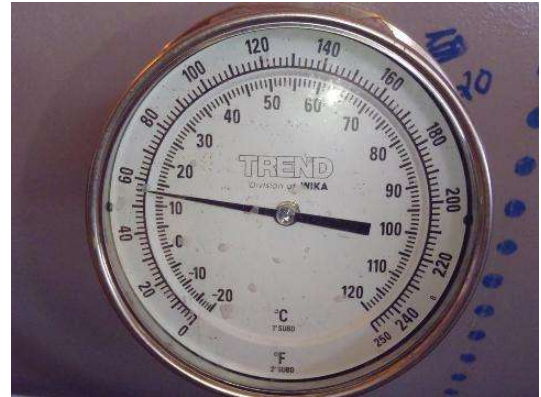
Figure: 14

Temperature Gauge
