Report No: DC1001237

Client	Apache Canada Ltd.	Inspection Date	Sep 8, 2013
Prov. Reg. #	AB 2781543	Inspection Type	VI / UT
Equipment Type	Treater	Location	Zama
Tag/Equip.	Treater	LSD	AB 09-28-117-04W6
Status	In Service	Downhole LSD	09-28-117-04W6
Manufacturer	Natco Canada Ltd	Area	Northern
Serial Number	L-8-340	Year Built	1991
CRN #	K-6455.2	Service	Sour
Comp/Unit Id		Manway	None
Nat.Board #		Coating	No
Interim Insp'n		Interim Type	
Next Inspection		Next Insp Type	
Length		Height	
Volume		Client Reference	
Owner	Apache Canada Ltd.	RT	1 HT No
Foreman	Bryan Gibbs	RAE Job No.	3801
ABSA	Plant: H Vessel: K Process: W Special: B	ASME	Sec. VIII div. 1
History Log

This vessel was inspected to the Apache 4.4PRD-002VS Category 2 Fired Separator procedure.

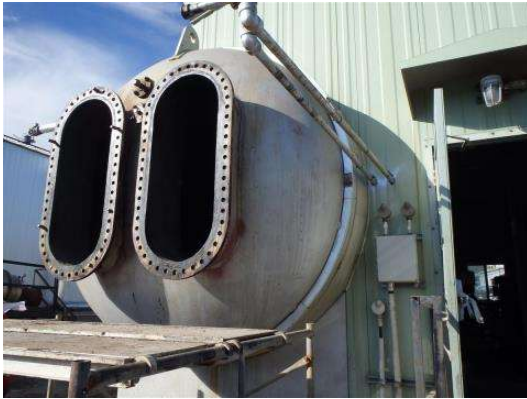
Figure: 2

External View

The Treater is located partially inside a building. The nameplate was legible and securely attached. The vessel was in the horizontal position and adequately supported. There are no makeshift structural attachments on the vessel shell or pressure containing components. There was no damage, distortion, or stress evident on piping connections.

The insulated/clad sections of the vessel showed no relevant indications of defects, damage or corrosion under insulation (CUI). The section of the shell not insulated/clad was fully painted, and the paint was in serviceable condition, with only minor scattered surface corrosion visible. The heads were insulated

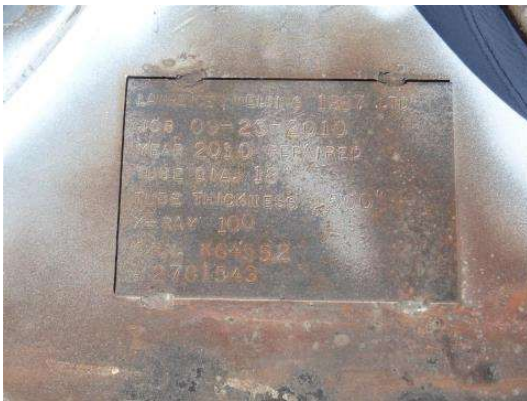
Figure: 3

Firetube Nameplate

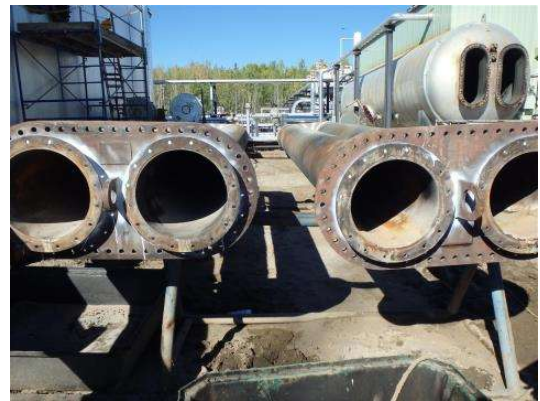
Figure: 4

The treater was fully inspected internally and on both the hot and cold sides. The firetubes were also visually inspected as well as inspected with MPI. The firetubes were free of defects and there was no significant metal loss due to corrosion.

Firetubes Bundles

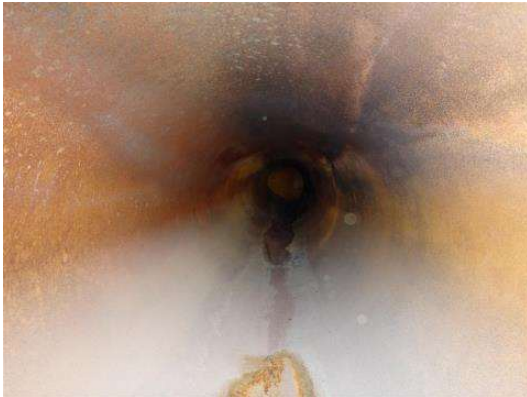
Figure: 5

Firetube Internals

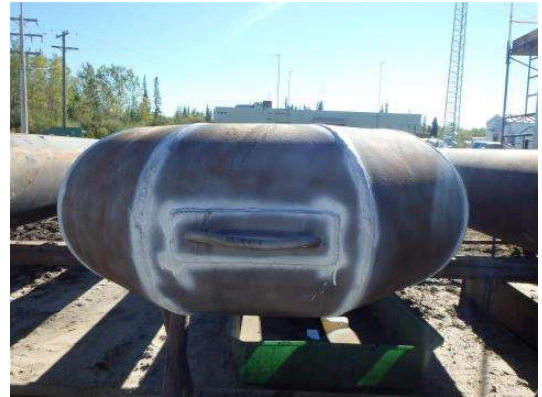
Figure: 6

The firetube support structure was in place and secure. The hanging supports for the firetube were slightly bent however the roller mechanisms were in serviceable condition.

Firetube Mitered Bends and Lug

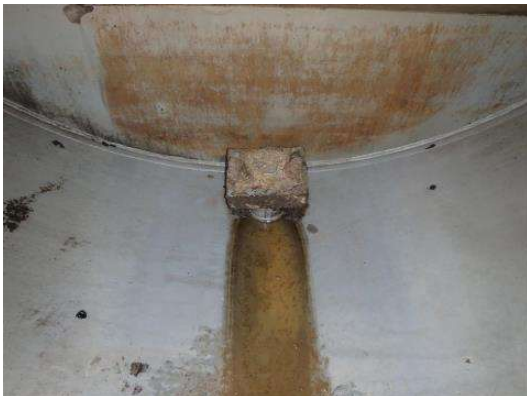
Figure: 7

Bottom of Treater Shell

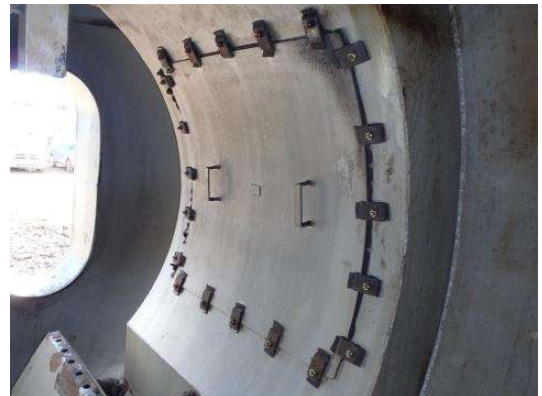
Figure: 8

The removable panels were not removed prior to inspection. The hot side was quite clean and the shell could be fully assessed.

Treater Access Panels

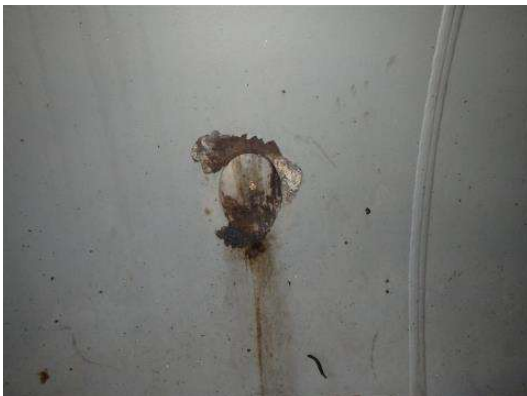
Figure: 9

The treater shell was coated and the coating has failed throughout the vessel and needs to be removed and the entire vessel re-coated. The areas where the coating has failed are not currently exhibiting any sign of corrosion. There were large hard deposits of asphaltines and paraffin throughout the hot side. These were removed when possible however some were so well adhered removal was not possible. There was no pitting or corrosion under those deposits.

Typical Coating Failure around Nozzles

This vessel has many large coating failures on both the hot and cold ends and should be completely re-coated at the next turnaround before corrosion and pitting begins. This re-coating will require approximately two weeks to complete however if timed with the turnaround at 3-10 several pieces of equipment could be blasted and coated within that window. Third party inspections for this size of remote field job are imperative in order to assure the full life of the coating. A loose budget for this vessel would be around \$100000 which would include dismantling, cleaning, blast, coating, remote mobilization etc.

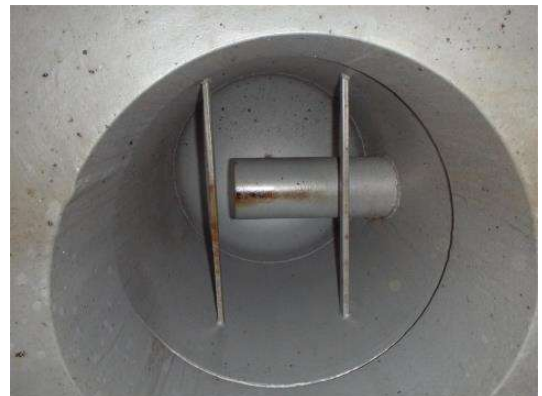
Figure: 10

Gas Boot

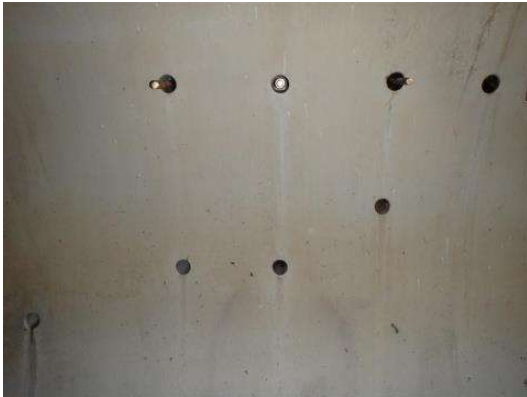
Figure: 11

Instrumentation Nozzles

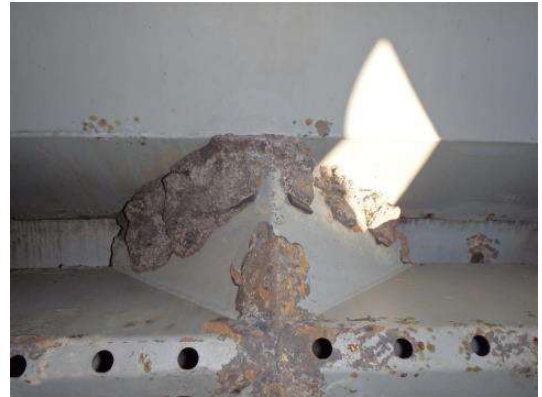
Figure: 12

Clumps of Asphaltines adhered to structure

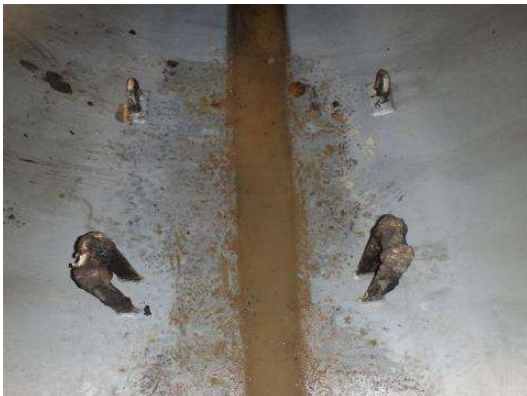
Figure: 13

The anodes were examined and found to be about 40% consumed. There were no issues with the treater however re-coating the vessel should be considered before corrosion takes place. The anode wooden rollers should be replaced each turnaround along with the anode.

Anode Rollers

Replace the anode rollers at the same time as the anodes.

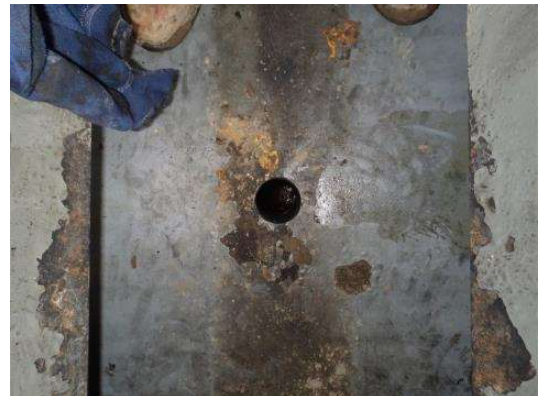
Figure: 14

Coating Failures

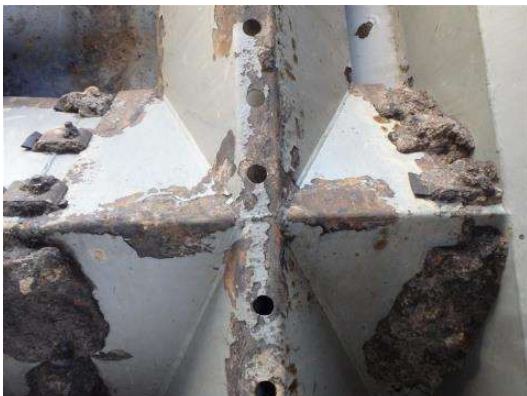
Figure: 15

Coating Failures and Adhered Deposits

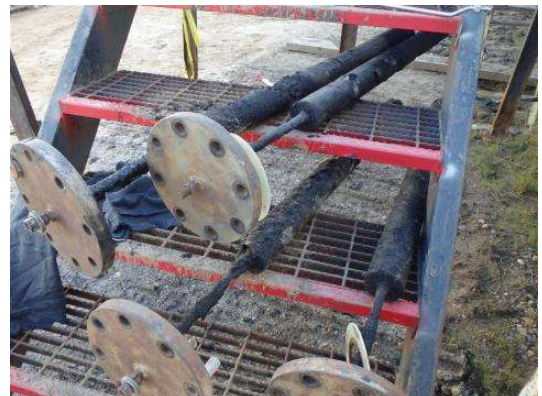
Figure: 16

Anode Condition

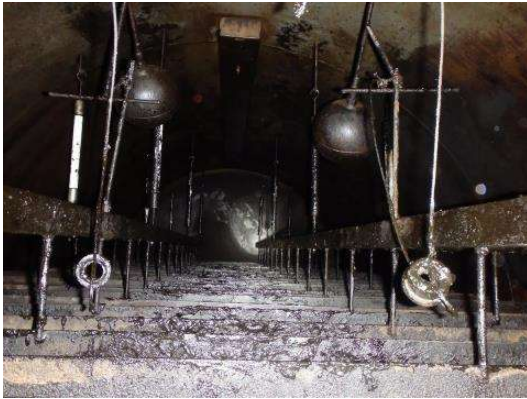
Figure: 17

Oil Side Vapor Space

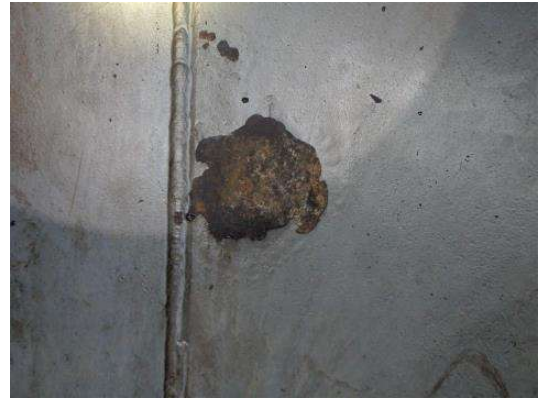
Figure: 18

The cold side of the treater was still very dirty. Access was quite limited however a reasonable assessment of the shell could be made. There were large coating failures however no pitting in those areas has begun. There were no deposits on the cold side though some sludge was still evident. The electrostatic grid had fallen down and was re-attached prior to inspection.

Typical Coating Failure - Oil Side

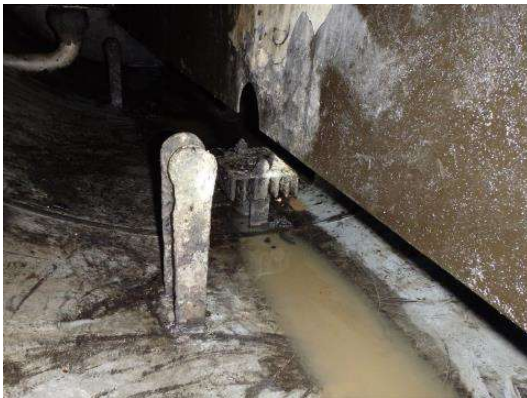
Figure: 19

Lower Shell Oil Side

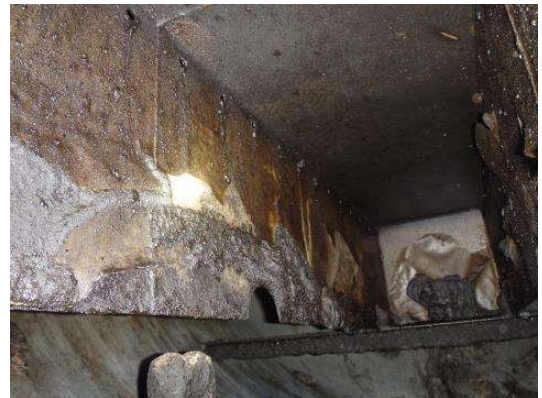
Figure: 20

Underside of Oil Side Channel

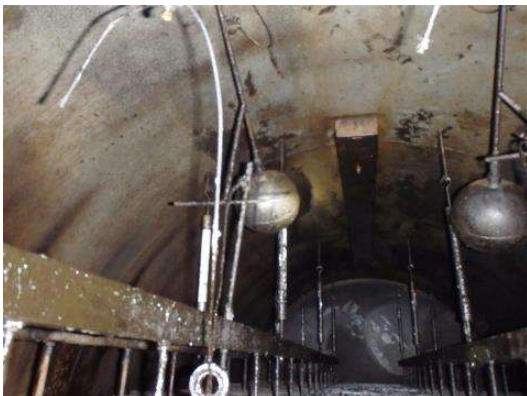
Figure: 21

Electrostatic Screen Attachments

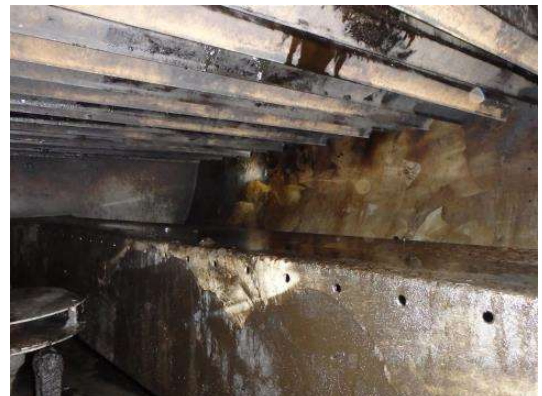
Figure: 22

Lower Shell Overview
