Pressure Vessel Inspection Audit		
		Job #:	Inspection Date:	Next Inspection Date:
		3448	02/26/2013	02/26/2013

Report No: DC1000920

Client	Apache Canada Ltd.	Inspection Date	Feb 26, 2013		
Prov. Reg. #	AB 2781543	Inspection Type	VE / UT		
Equipment Type	Treater	Location	Zama		
Tag/Equip.	Treater	LSD	AB 09-28-117-04W6		
Status	In Service	Downhole LSD	09-28-117-04W6		
Manufacturer	Natco Canada Ltd	Area	Northern		
Serial Number	L-8-340	Year Built	1991		
CRN #	K-6455.2	Service	Sour		
Comp/Unit Id		Manway	Yes		
Nat.Board #		Coating			
Interim Insp'n		Interim Type			
Next Inspection		Next Insp Type			
Length		Height			
Volume		Client Reference			
Owner	Apache Canada Ltd.	RT	1	HT	YES
Foreman	Bryan Gibbs	RAE Job No.	3448		
ABSA	Plant: H Vessel: K Process: W Special: B	ASME	Sec. VIII div. 1		
History Log

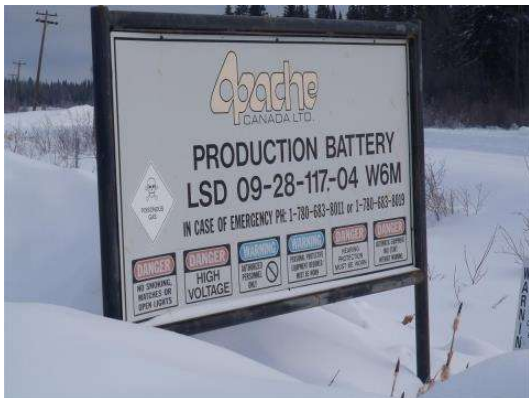
Figure: 1

LSD Sign

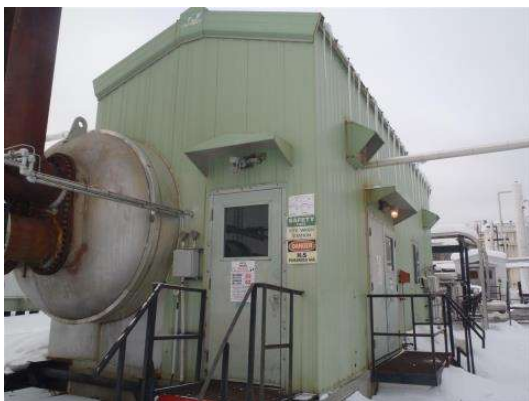
Figure: 2

The building was generally in serviceable condition. The floor was clean and in serviceable condition. The cladding was generally in serviceable condition. The building structure was adequately supported, level, and the ground wire was securely attached.

Building Overview

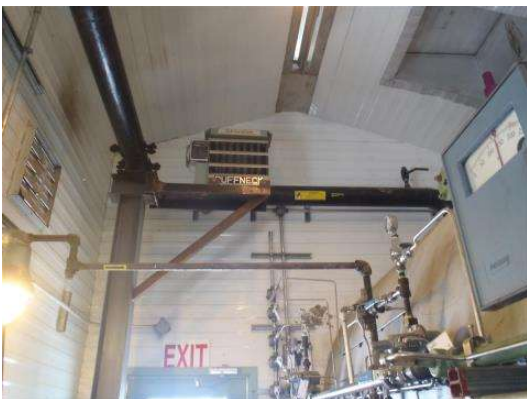
Figure: 3

The attached piping was generally in serviceable condition. It was sufficiently supported with no damage, distortion or undue stress evident. Contents and flow direction were clearly marked. The threaded joints were properly connected, and exhibited no signs of leakage.

Inlet Piping

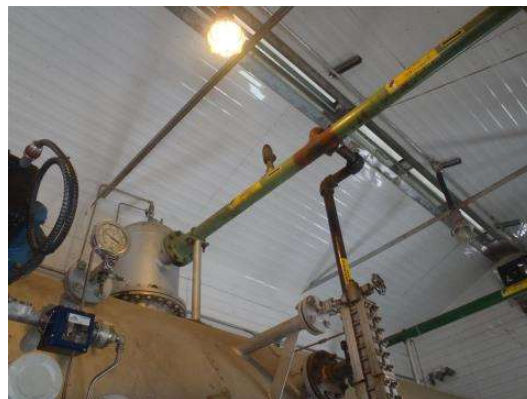
Figure: 4

Outlet Piping

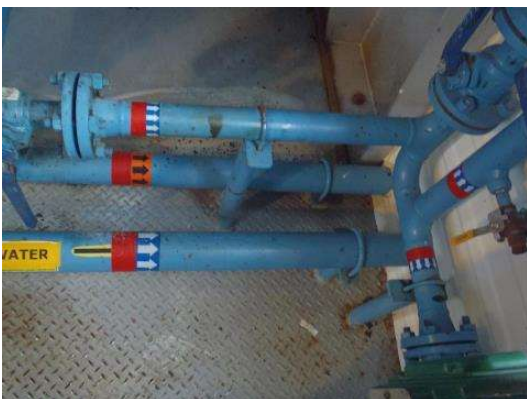
Figure: 5

Produced Water / Sour Crude Outlet Piping

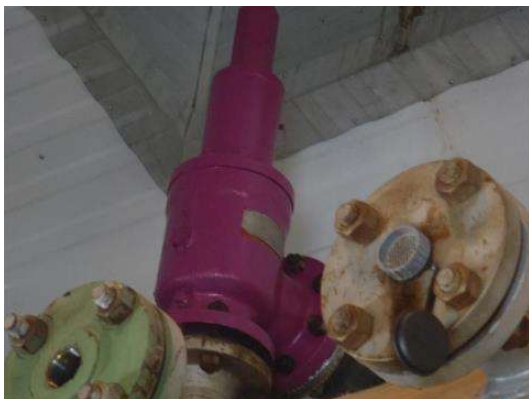
Figure: 6

There was no safe access to the PSV mounted on top of the treater. The set point and service details could not be obtained either.

PSV Overview

Comments:
Require PSV and UT reports for assessment of the vessel

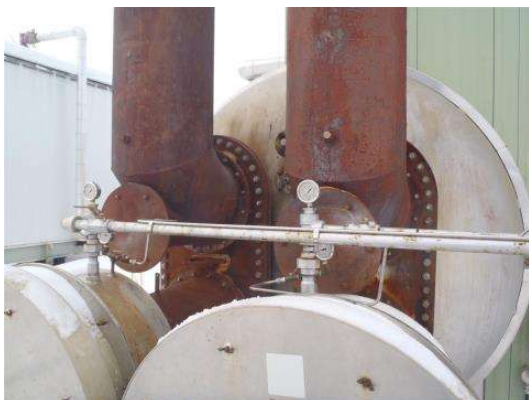
Figure: 7

The fire tube flange connection was fully bolted and showed no evidence of leakage. The sight glass on the firebox was clear and in serviceable condition. The flame arrestor appeared clean and in serviceable condition. The stack was bare steel. The stack to firetube exhaust flange was fully bolted and showed no signs of leakage.

Fire Tubes and Stack

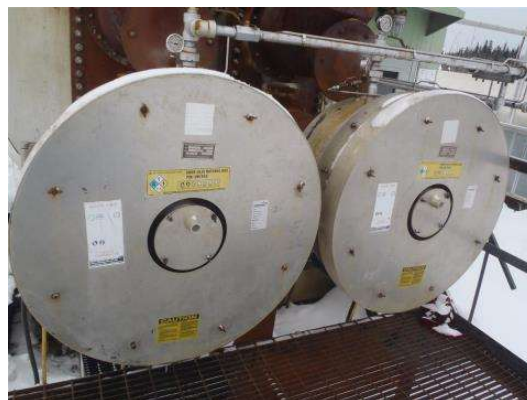
Figure: 8

Spark Arrestors and Fuel Gas Piping

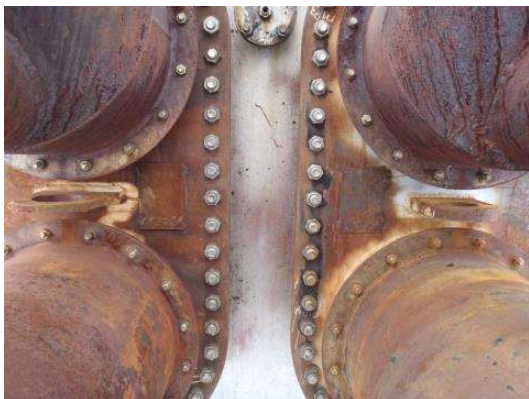
Figure: 9

Fire Tube Nameplates

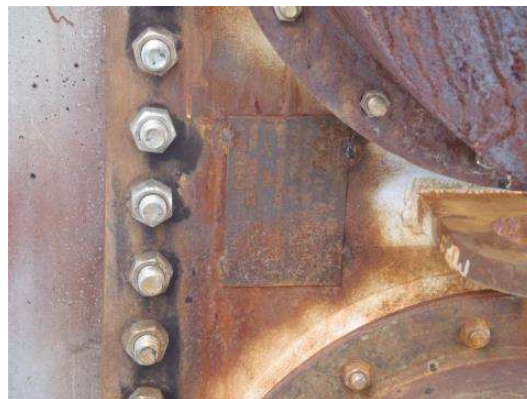
Figure: 10

Nameplate Close Up

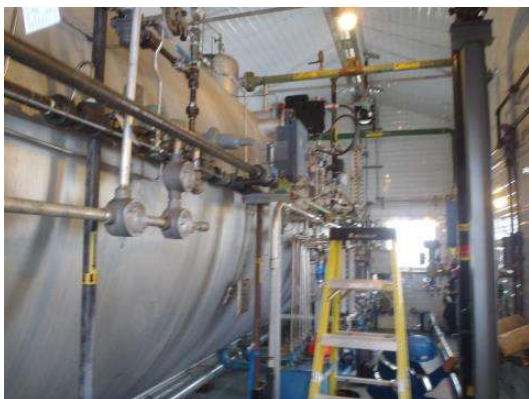
Figure: 11

The Treater is located partially inside a building. The nameplate was legible and securely attached. The vessel was in the horizontal position and adequately supported. There are no makeshift structural attachments on the vessel shell or pressure containing components. There was no damage, distortion, or stress evident on piping connections.

The insulated/clad sections of the vessel showed no relevant indications of defects, damage or corrosion under insulation (CUI). The section of the shell not insulated/clad was fully painted, and the paint was in serviceable condition, with only minor scattered surface corrosion visible. The heads were insulated

Vessel Overview

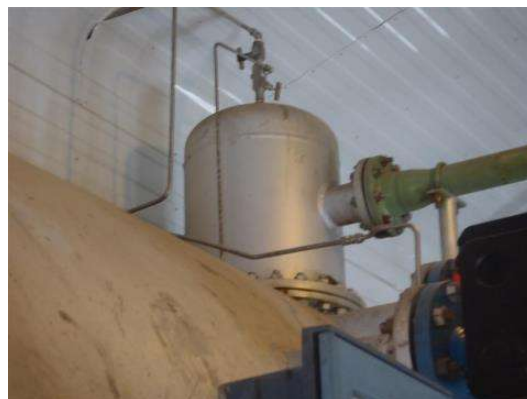
Figure: 12

Gas Boot

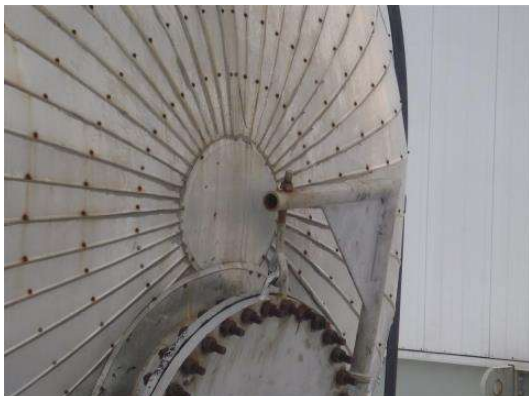
Figure: 13

Manway Davit Arm and Single Nut
