Report No: DC1000920

Client	Apache Canada Ltd.	Inspection Date	Feb 26, 2013		
Prov. Reg. #	AB 2781543	Inspection Type	VE / UT		
Equipment Type	Treater	Location	Zama		
Tag/Equip.	Treater	LSD	AB 09-28-117-04W6		
Status	In Service	Downhole LSD	09-28-117-04W6		
Manufacturer	Natco Canada Ltd	Area	Northern		
Serial Number	L-8-340	Year Built	1991		
CRN #	K-6455.2	Service	Sour		
Comp/Unit Id		Manway	Yes		
Nat.Board #		Coating			
Interim Insp'n		Interim Type			
Next Inspection		Next Insp Type			
Length		Height			
Volume		Client Reference			
Owner	Apache Canada Ltd.	RT	1	HT	YES
Foreman	Bryan Gibbs	RAE Job No.	3448		
ABSA	Plant: H    Vessel: K    Process: W    Special: B	ASME	Sec. VIII div. 1		
History Log

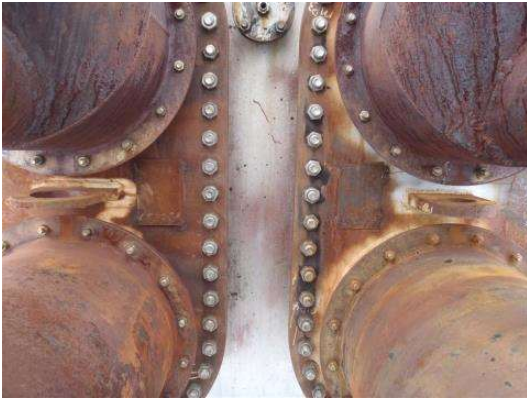
Figure: 9

Fire Tube Nameplates

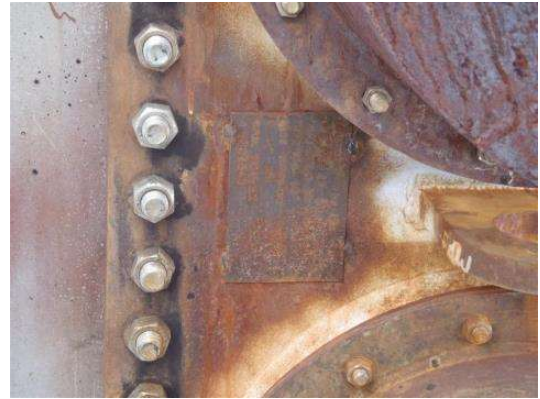
Figure: 10

Nameplate Close Up

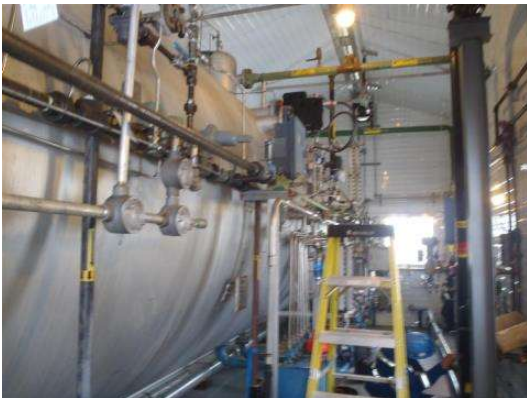
Figure: 11

The Treater is located partially inside a building. The nameplate was legible and securely attached. The vessel was in the horizontal position and adequately supported. There are no makeshift structural attachments on the vessel shell or pressure containing components. There was no damage, distortion, or stress evident on piping connections.

The insulated/clad sections of the vessel showed no relevant indications of defects, damage or corrosion under insulation (CUI). The section of the shell not insulated/clad was fully painted, and the paint was in serviceable condition, with only minor scattered surface corrosion visible. The heads were insulated

Vessel Overview

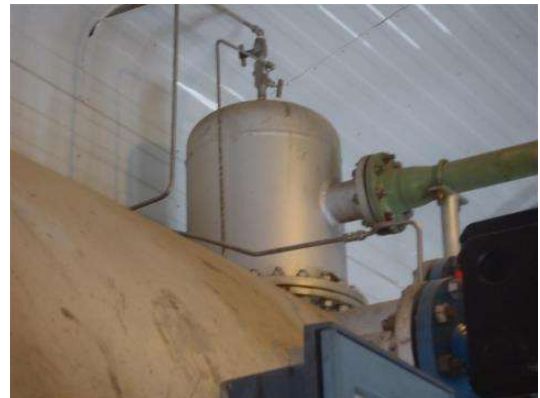
Figure: 12

Gas Boot

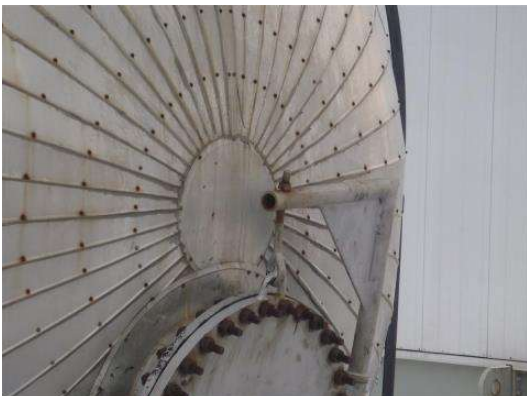
Figure: 13

Manway Davit Arm and Single Nut
