# Pressure Vessel Visual Inspection Report

Location: Vermilion Battery - 14-18-050-06w4  
Eq# 66160151, Inclined Cold FWKO, Corlac serial #FWK-069, A#411824, CRN L6426.231  
MAWP 100psi @ -20F

<b>Equip Id</b>	66160151	<b>SAP ID</b>	66160151	<b>Asset Type</b>	
<b>Plant</b>	Lloydminster Production	<b>Unit</b>	Mannville/Swimming	<b>System</b>	N/A
<b>Description</b>	FWKO,				
<b>FLOC</b>	H1-01-004-00006	<b>LSD</b>	14-18-050-06W4		
<b>Insp Date</b>	Aug 15, 2018	<b>Inspector</b>	Luke Newport	<b>Insp Type</b>	VIInt
<b>Company</b>	Inspector	<b>Confidence</b>	High

A visual external and internal inspection was performed to verify the integrity of the FWKO. The FWKO was found to be generally in fair condition although immediate minor coating repairs were required.

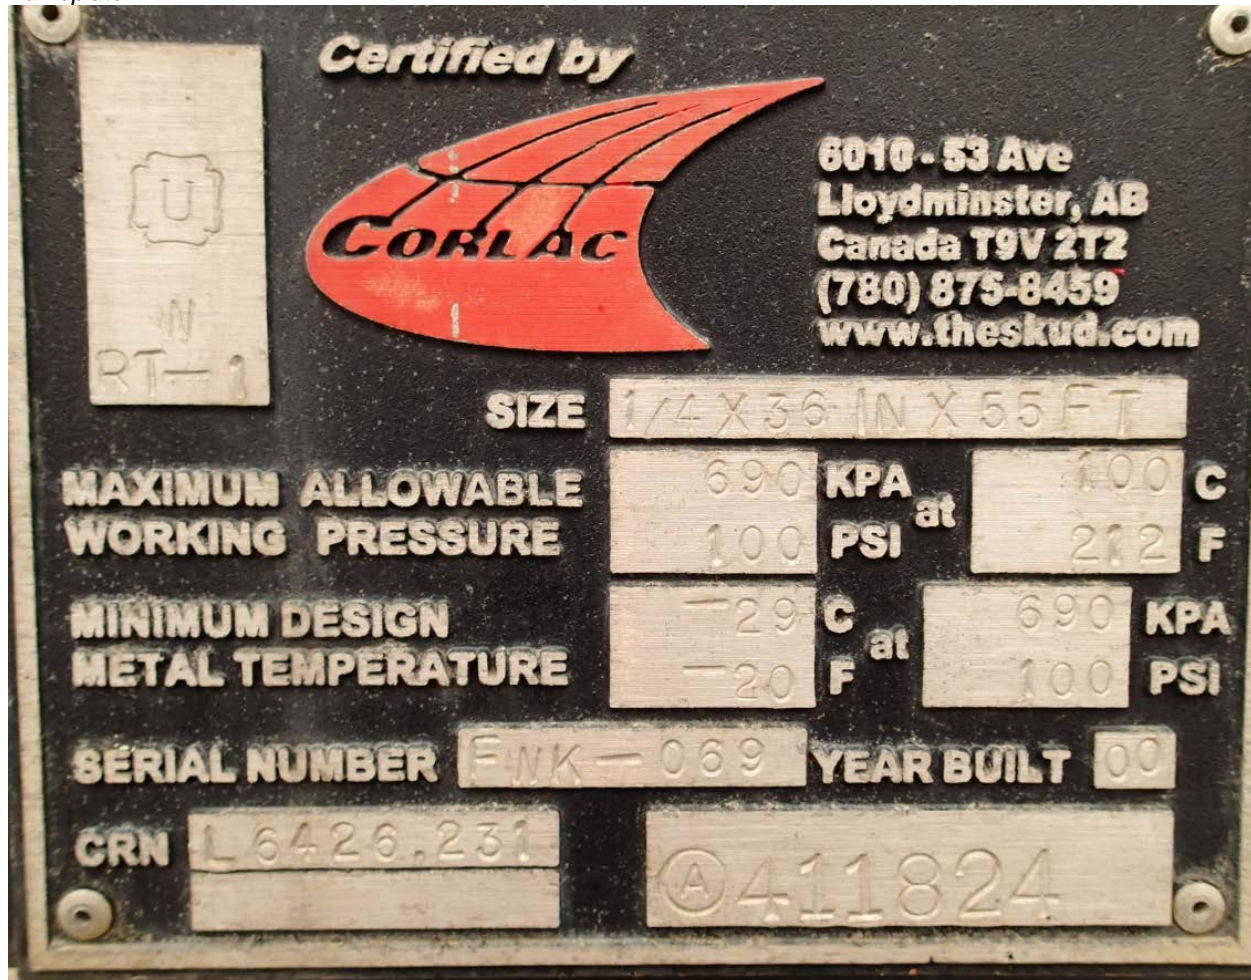
ID	Description	Condition	Location	NCR	Comment
V1	General Other (Please Explain)	Fair			Nameplate in place and legible, Alberta CRN attached.
V7	Heads	N/A			Fully Insulated
V9	Electrical Ground	Fair			The vessel is grounded through the piles.
V13	Gauge/Site Glass	Fair			Both pressure gauges and temperature gauge need replaced.
V14	Shell	N/A			Fully Insulated
V22	Foundation	Fair			Vessel is supported by two saddles which are anchor bolted to a steel I- beam that rests on piles.
V31	Connections Other (Please explain)	Fair			Pipe alignment is acceptable.
V33	Nozzles	N/A			Fully Insulated
V34	Manways	Fair			Acceptable
V41	Insulation Other (Please explain)	Poor			Vessel is insulated with sprayed on urethane foam. The insulation is starting to blister and disbond at some locations. These locations should be removed and repaired to prevent corrosion under insulation from occurring to the shell.
V51	Relief Devices Other (Please explain)	Yes			The PSV protecting the vessel is mounted off the top of the vessel. The PSV was removed from the vessel at the time of inspection and sent to APEX for servicing.

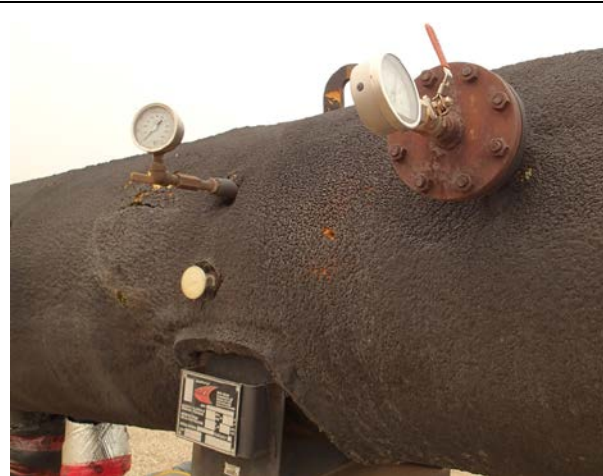
The two pressure gauges and one temperature gauge that need replaced.

- coating repairs were required due to damage from cleaning
- the insulation that is blistering and disbonding should be repaired to prevent corrosion under insulation from occurring
- replace both pressure gauges and the temperature gauge
- remove the sand from behind the top weir
- the FWKO will be due for inspection in 5 years 2023. At that time:
  - Complete external and internal visual inspection

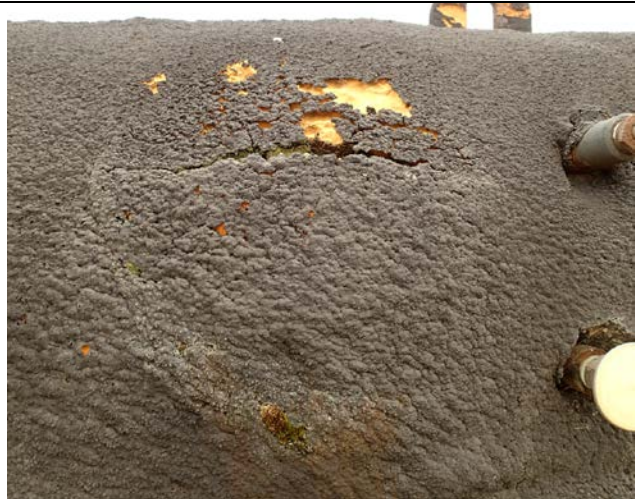
One of the locations on the vessel where the insulation is disbonding and blistering.

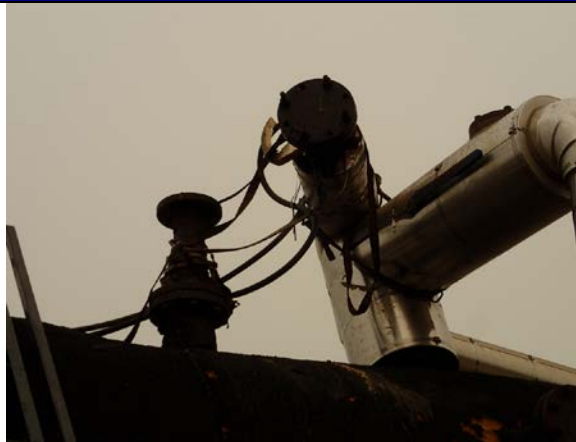
*The PSV removed from the vessel.*

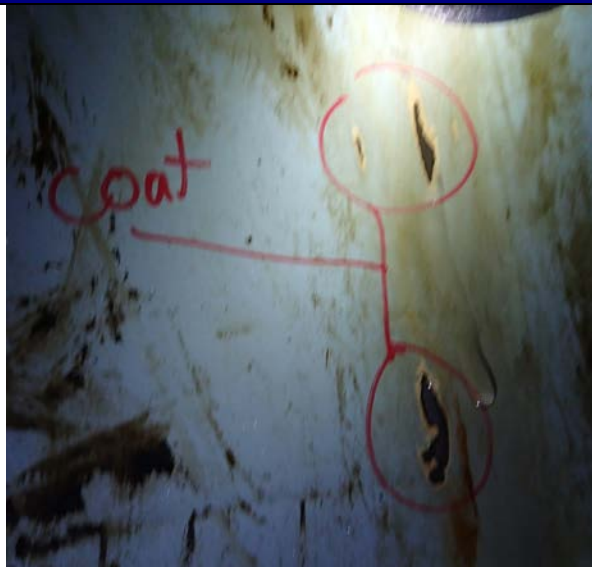
ID	Description	Condition	Location	NCR	Comment
V7	Heads	Fair			Bottom head and top portion of top head no concerns noted.
V8	Welds	Fair			Acceptable
V9	Nozzles	Fair			Acceptable
V10	Shell	Fair			Acceptable
V11	Gasket Surfaces	Fair			Acceptable
V21	Internals Other (Please explain)	Fair			Desand Piping - Acceptable
V23	Baffle/Wier	Fair			Weirs secure
V25	Thermowells	Fair			Acceptable
V27	Nonmetallic Linings	Fair			Vessel is fully internally coated. A few coating failures were identified on the bottom of the vessel from the manway up to the removable weir from cleaning. These failures were marked out for repair.

*One area that requires coating repair in the vessel.*

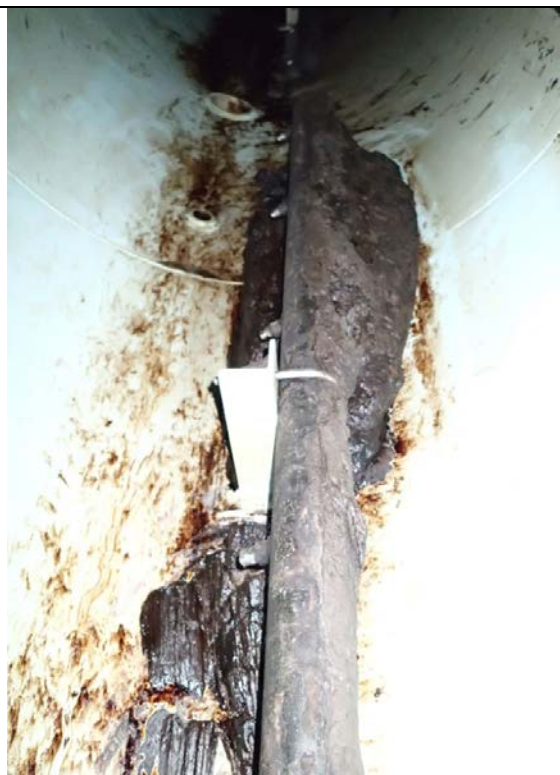
*Some slop that was not removed from the vessel.*

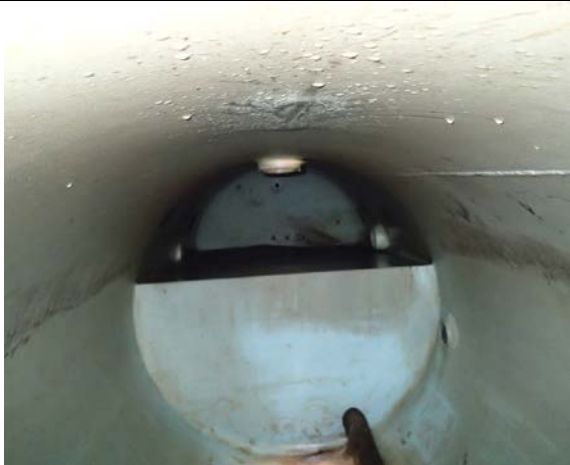
<p><i>The weir at the top of the vessel.</i></p>
  <p>The sand that has accumulated behind the top weir in the vessel.</p>
